## TEST REPORT

No. : XMIN2310001181CM06-1\_EN

Sample Name : Porcelain Tile - Group Bla

1. Test Item: Dynamic Coefficient of Friction

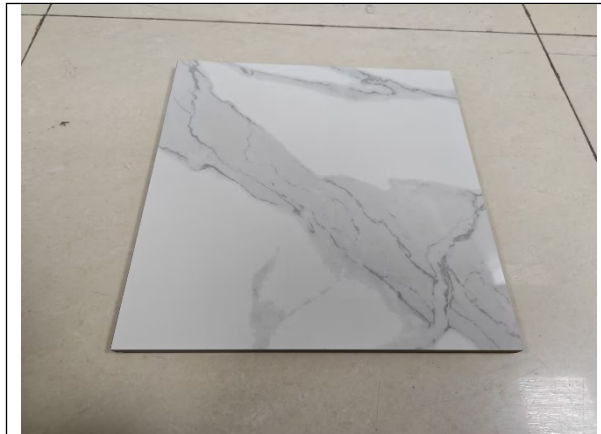
### Original Sample Photo:

Other Information : Polish

Sample Description: See photo

Test surface: see photo
